Air Warfare Centre

Produced by QinetiQ in collaboration with the Air Warfare Centre

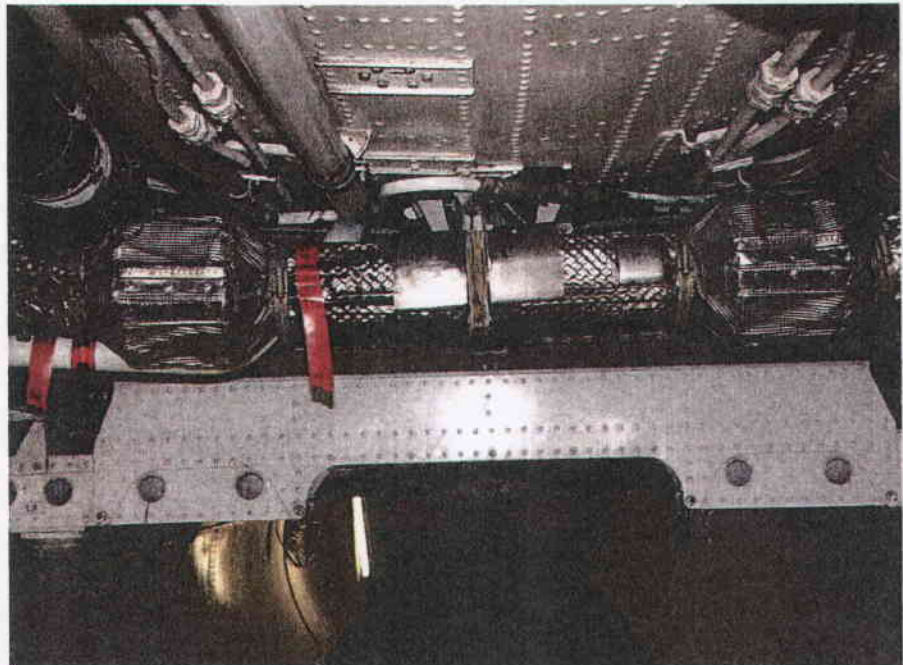
Figure 2-1; Cross feed duct shroud half clamp seams incorrectly orientated on XV254

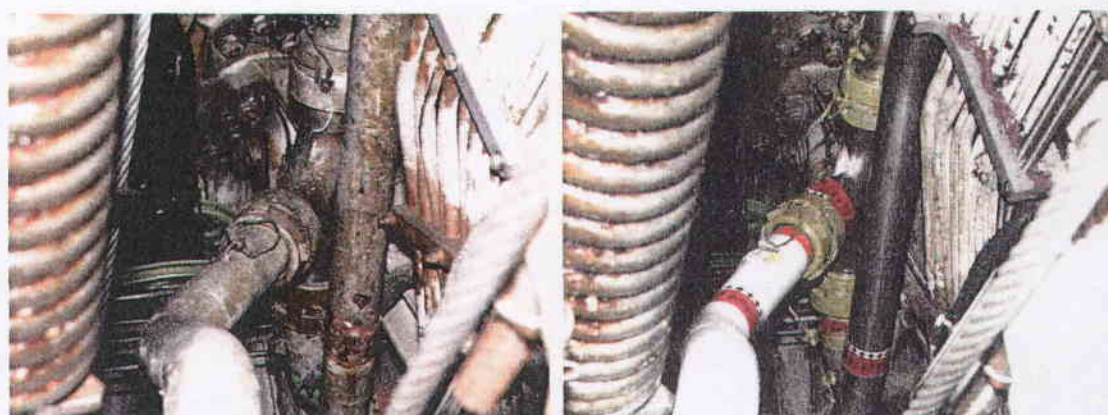
Figure 2-2; Illustration of the fuel system pipework on XV254 and XV229

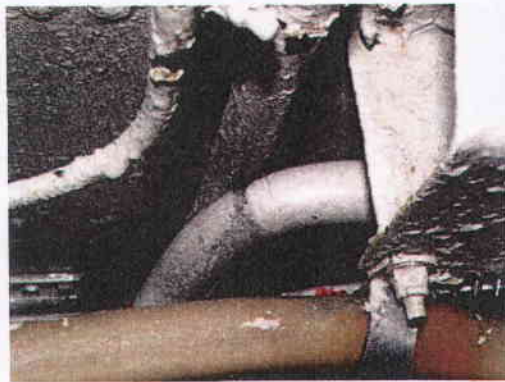
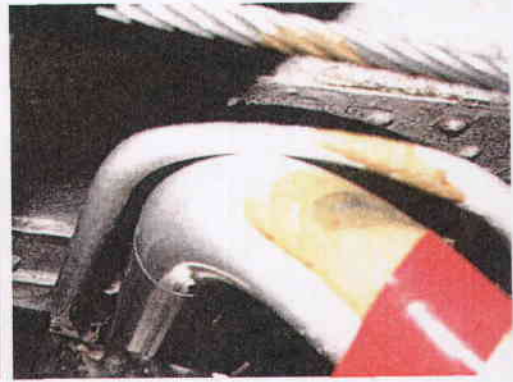
Figure B-5; Signs of damage and insufficient clearance between pipes

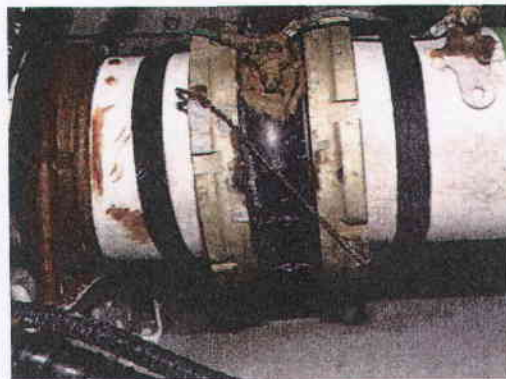
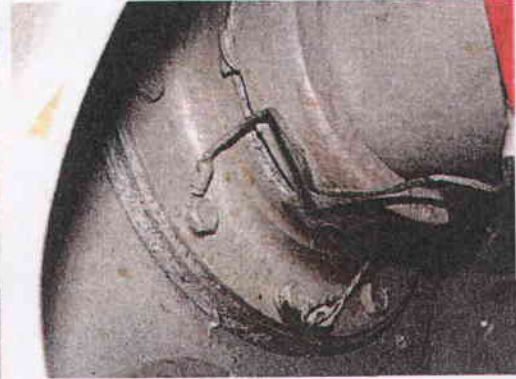
Figure B-6; Corrosion on fuel couplings

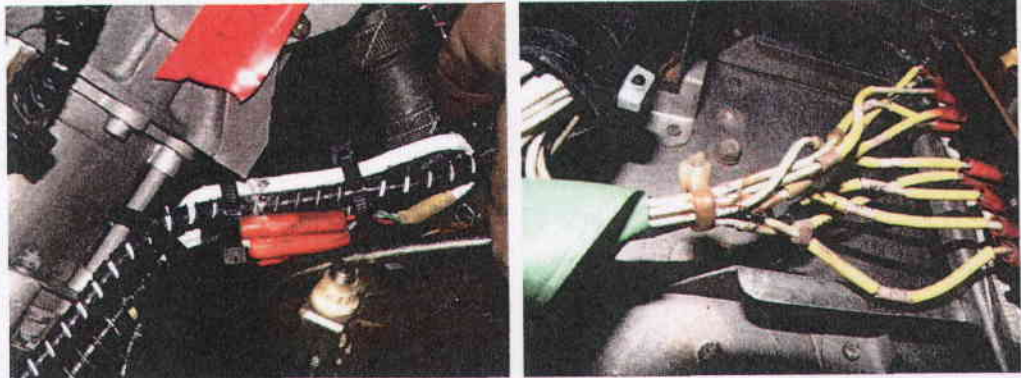
*Figure B-7; damage to electrical cables*

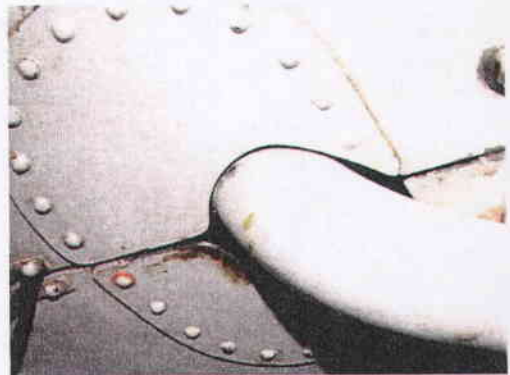
*Figure D-7; Fuel pipe interfering with structure and showing signs of damage*

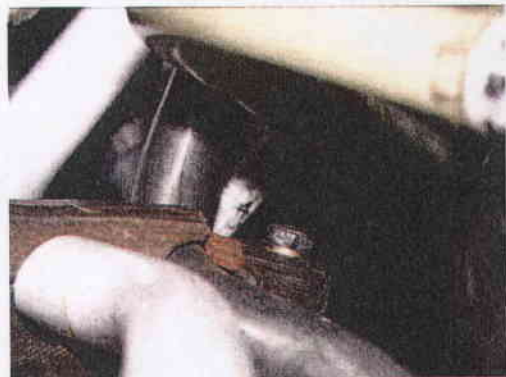
*Figure D-8; Damage to fairlead*

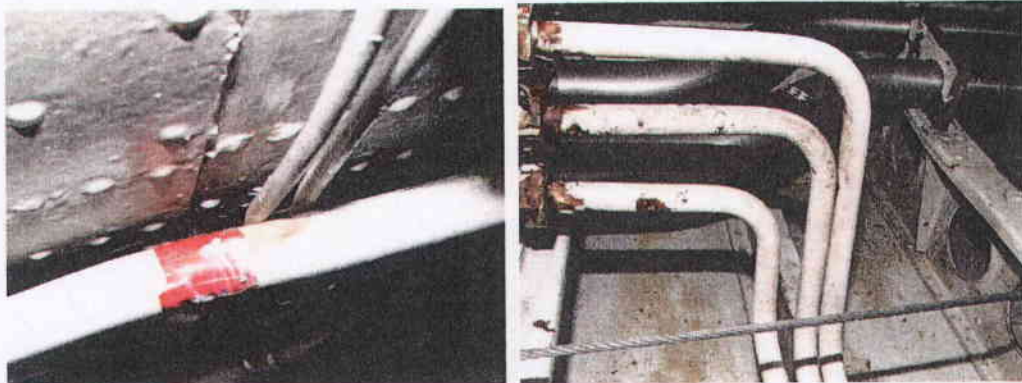
*Figure D-9; Clearance between pipes not within the fuel system*

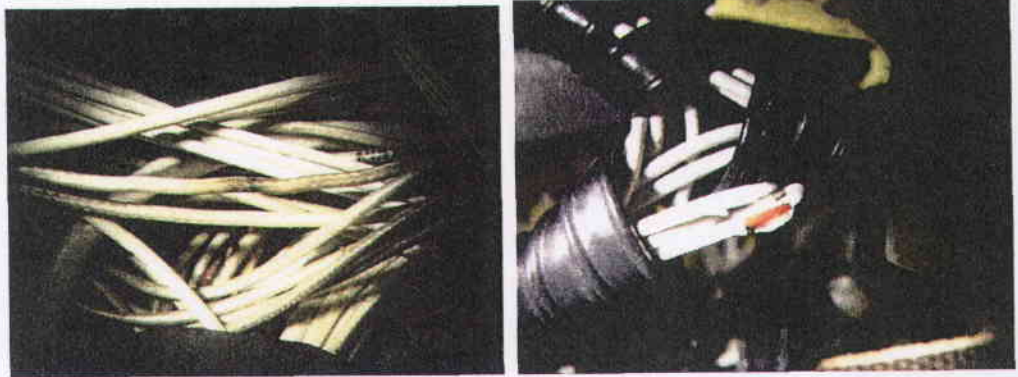
Figure D-13; Damage found on electrical cables

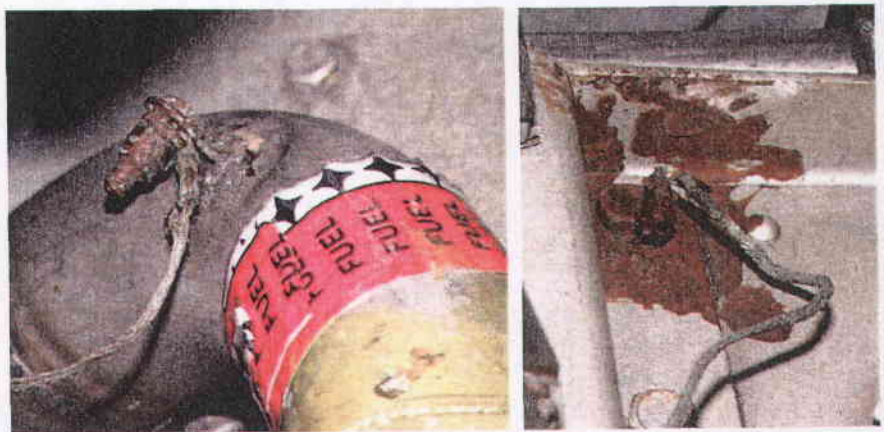
Figure D-14; Damage found on bonding leads

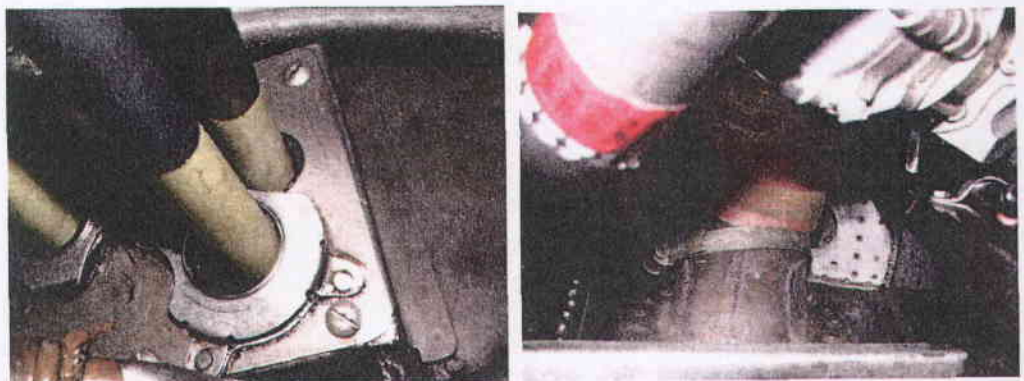
Figure D-15; Control rods and clearance to structure, loose component

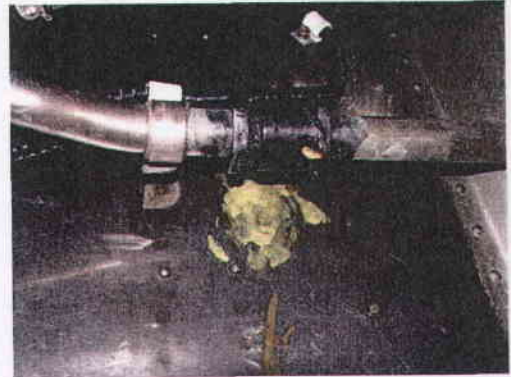
*Figure D-16; Signs of overheating of protective coating*
