DATE	8 AUG 2007		LOCATION AND GRID REFERENCE	HUDSWELL GRANGE CATTERICK TRAINING AREA SE. 139 987		
AIRCRAFT TYPE(S)	MARK(S)		SERIAL NUMBER(S)	PARENT UNIT(S)		
PUMA	HCI		ZA 934	RAF BENSON		
NAME(S) OF PILOT(S)	Flt Lt SALE (Capt)		PARENT UNIT(S)	33 SQN RAF BENSON		
	Flt Lt HAMILTON (Co)					
NUMBER OF CASUALTIES						
KILLED			INJURED			
CREW	PASSENGERS	OTHERS	CREW	PASSENGERS	OTHERS	
2	1	-	1	8	-

SERVICE INQUIRY INTO THE ACCIDENT INVOLVING PUMA MK1 ZA934 ON 08 AUG 07

**SERVICE INQUIRY REPORT INTO THE
RAF PUMA HELICOPTER ZA934 ACCIDENT
AT HUDSWELL GRANGE, CATTERICK TRAINING AREA
ON THE 8 AUGUST 2007**

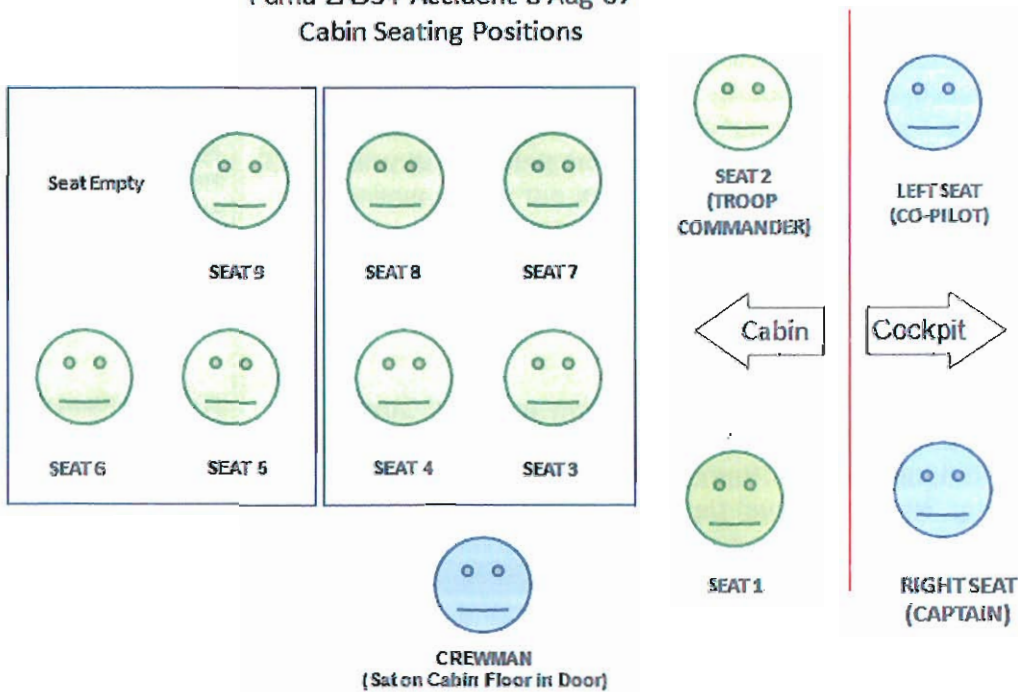
(Fig 1. Seating Positions on ZA934 on 8 August 2007)

e. Nine Army passengers from the 1st Scots, Infantry Training Company (ITC) were onboard ZA934 at the time of the accident; a Troop Commander and 8 basic recruits. The recruits were on light duties, due to sickness or minor injury, as the support troop to the main exercise training effort being conducted that day. The Troop Commander was the 1st Scots ITC aviation liaison and interface with the crew of ZA934 for that days tasking. An overview of the seating positions at the time of the accident is shown at Fig 1 (Names & Pictures at Annex A).

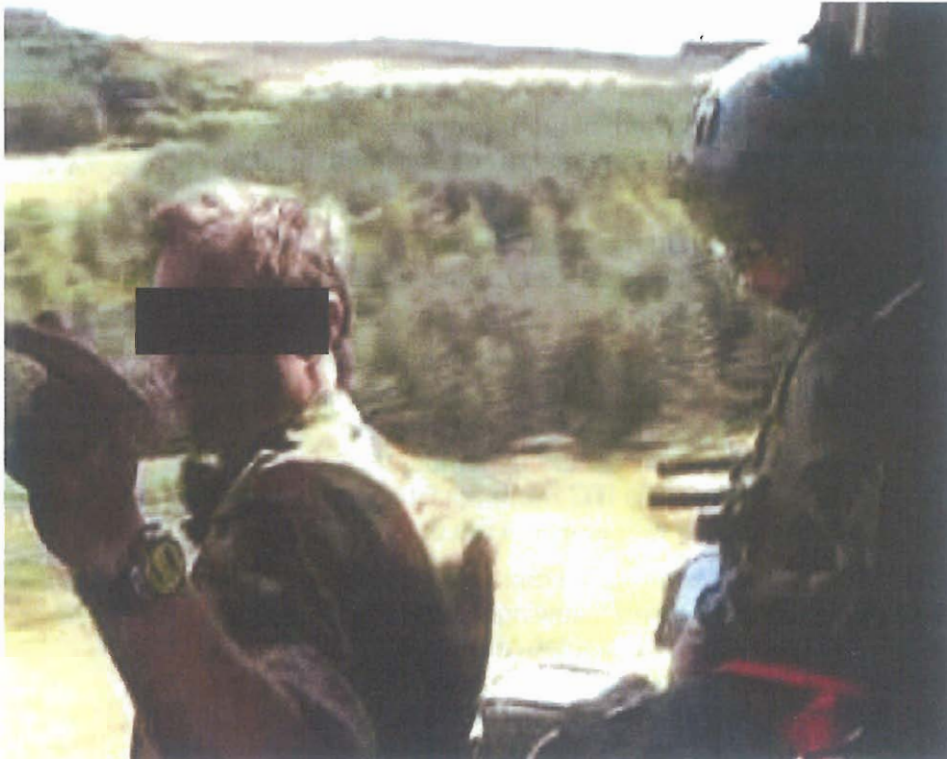
(Fig 6 – Troop & Crewman sat on doorsill at Low-Level.)

[Fig 6] Image taken by troops onboard ZA934 during tasking on 8 August 07. Picture shows ITC Troop and Crewman sat on the aircraft doorsill during low-level flight. Note the troops dress; short sleeves and no head or apparent hearing protection. Regulation J.130.105.1 Refers.

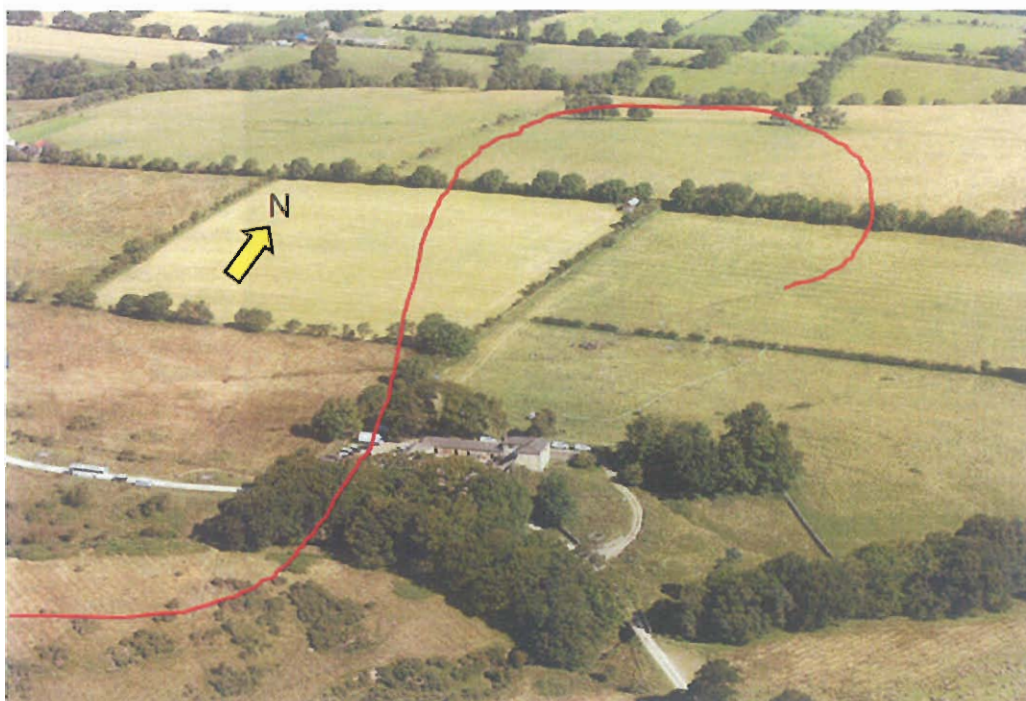
(Fig 8 – Accident site, Hudswell Grange Farm)

27. The crew continued West, then South along the Swaledale Valley, conducting TAC CLIMB and 'bunting' manoeuvres [37], turning East to run in towards Hudswell Grange Farm at low-level. The Captain and Co-pilot 1 discussed the route into the Farm and the Captain elected to overfly the ITC Paratroops from the South, executing a 'Repositioning Turn' so as to overfly the troops a second time on departure back to Shaiba (See Fig 8 and Note [38]).

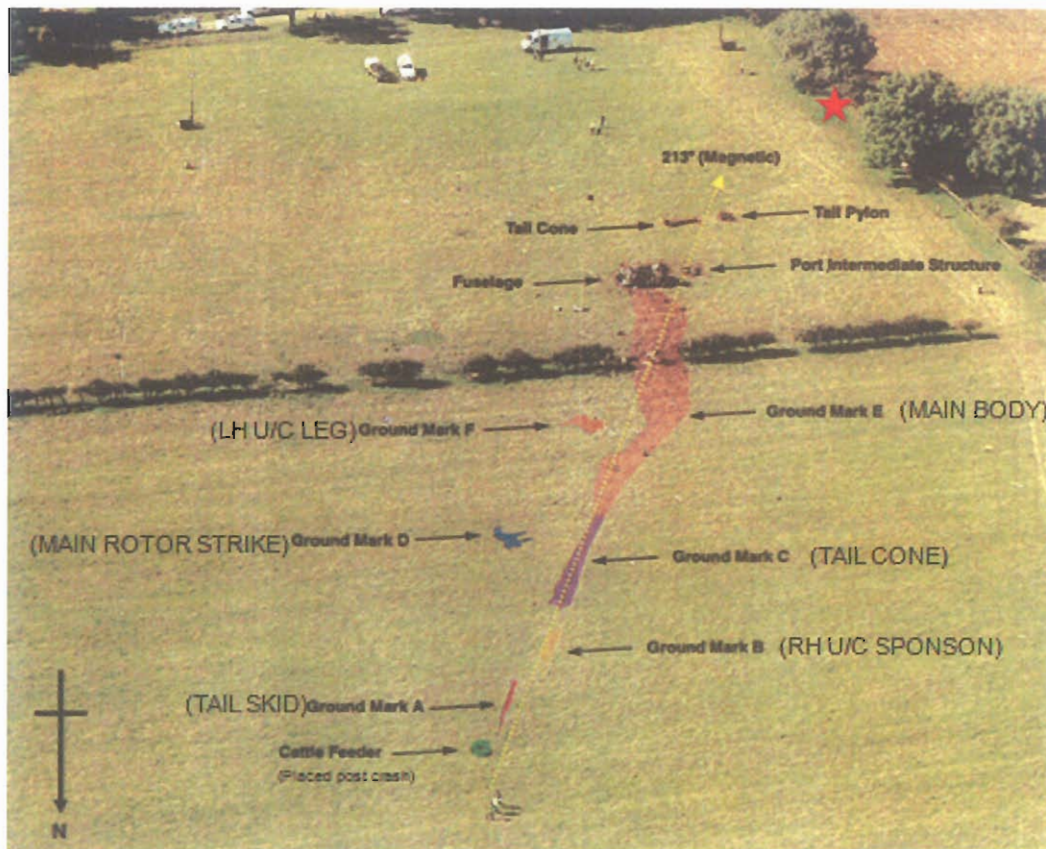
30. **Impact Sequence** Witness accounts and analysis by the Materials Integrity Group, utilising ground marks, airframe and other physical evidence indicated that ZA934 struck the ground tail first, then tumbled across the field, through a low Hawthorn tree-line before coming to rest on its left side (See Fig 9 and [43]).

[Fig 9] The Point of Impact, ground markings and wreckage trail at Hudswell Grange.

The red star (top right of picture) indicates where the Crewman was found, some 65 metres from the fuselage.

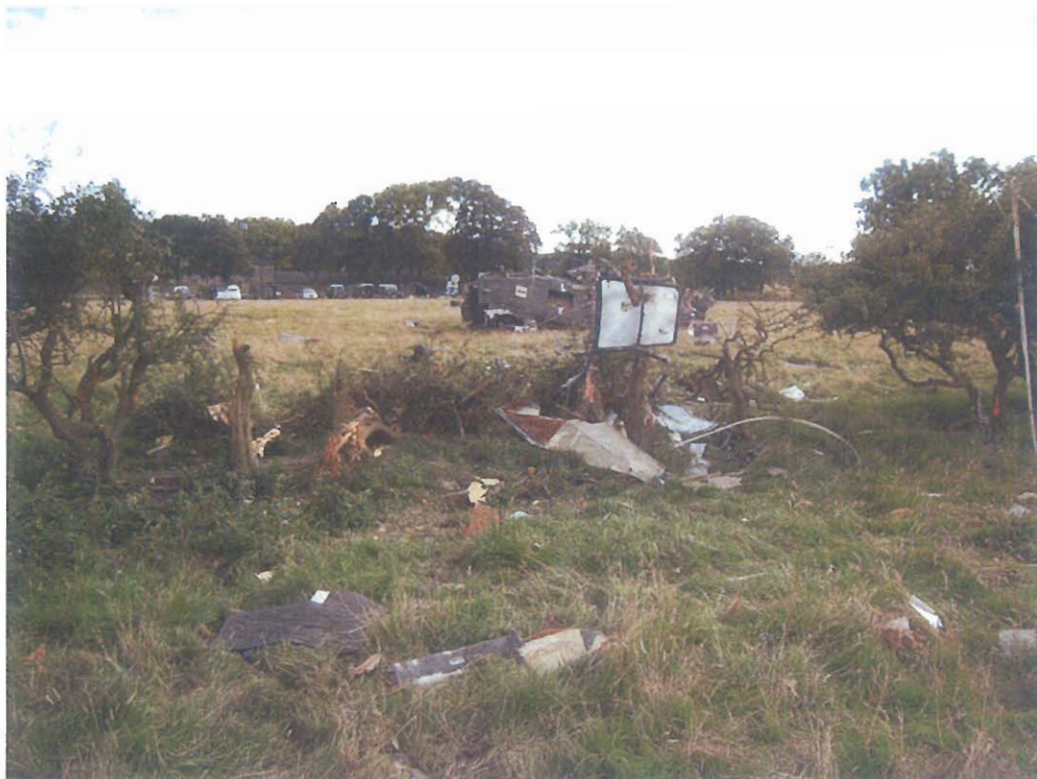
(Fig 10 – Hawthorn tree-line, Hudswell Grange)

[Fig 10] Remains of the Hawthorn tree-line at Hudswell Grange that ZA934 passed (inverted) through. Note centre cockpit window impaled on tree stump.

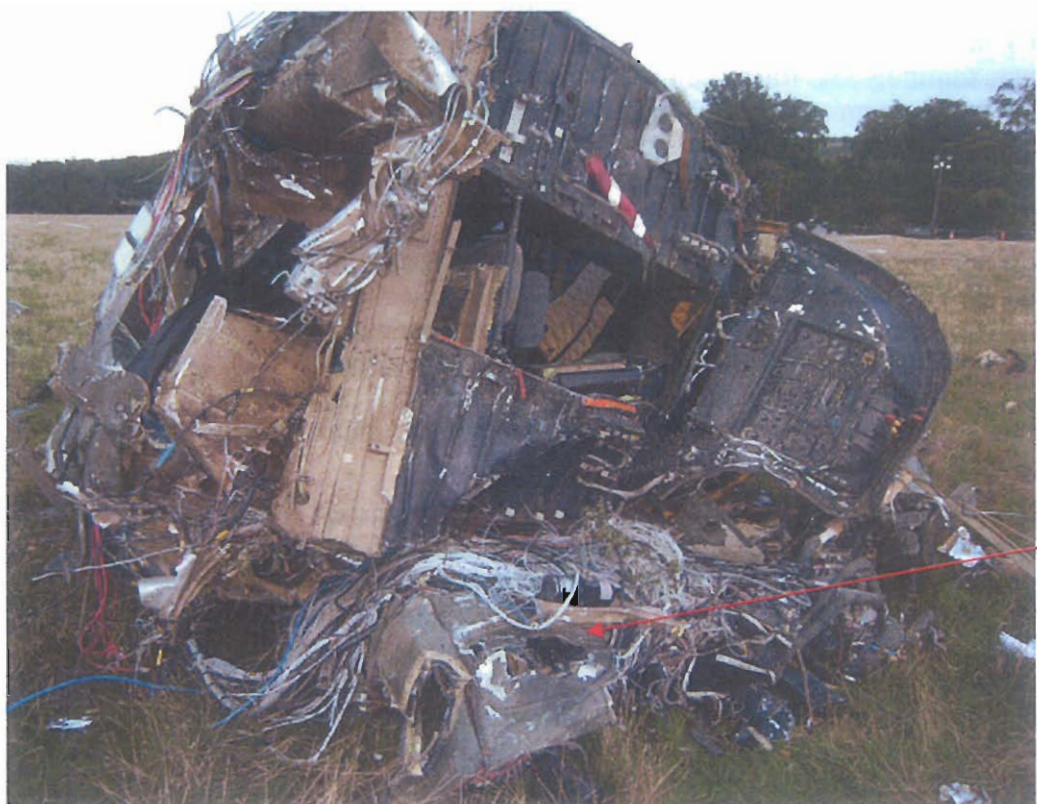
(Fig 11 – ZA934 Cockpit area – see note)

[Fig 11] – ZA934 post crash at Hudswell Grange. The picture shows the front of the aircraft and the remains of the cockpit area.

The CVR was found amongst the wreckage (remains of Left Hand Seat cockpit floor) at centre bottom of the photo (indicated by red arrow).

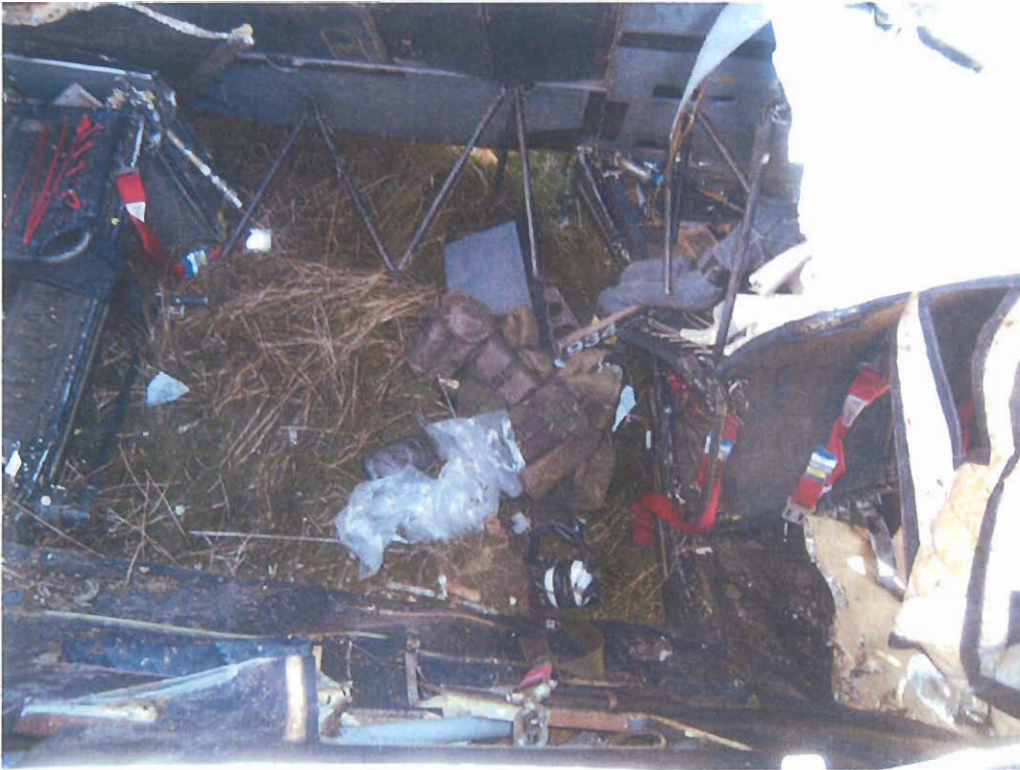
(Fig 12 – ZA934 Cabin area)

36. It is noteworthy that a number of injuries to troops seated in the cabin, despite being correctly secured and wearing combat helmets, were aggravated by loose cabin equipment such as the aircraft parking chock and the under-slung load strop (See Fig 12 Notes).

[Fig 12] ZA934 Cabin viewed from the right cabin door. The Airframe is resting on its left hand side. The forward left side mounted cabin seat can be seen at the top left corner of the picture.

Also note the excess of loose equipment (both troops and role equipment) in the picture – aircraft chock (with white numbers '934') and Under slung load strop.

c. **Stowage of Role Equipment.** RAFCAM Investigations indicated that injuries were caused by loose equipment in the cabin after impact. The Panel recommends that:
