51S/402/1/1/ENG

POTENTIAL FIRE IGNITION SOURCES MEETING 11 FEB 08

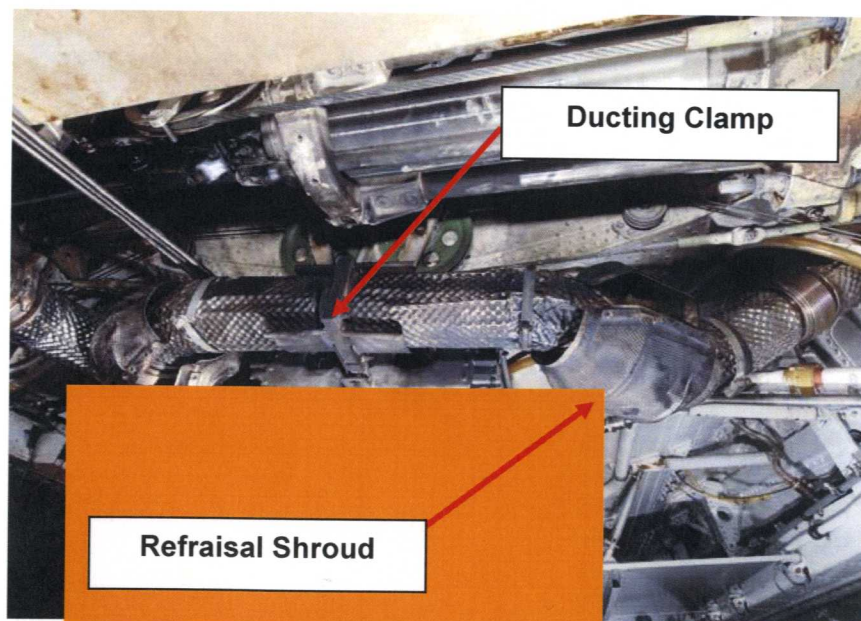
Figure 1 – Overview of Air-Start Cross-Feed Ducting Assembly

11. During inspection of the air-start cross-feed ducting clamp assembly (see Figure 1), it was noted that:
 - a. There was a pungent smell of fuel on the upper half of the clamp.
 - b. There was delamination of the clamp material (the clamp is manufactured from asbestos plys with rubber bonding).
 - c. There was heavy sooting directly above clamp location within the Bay.
 - d. There were burn marks and heavy sooting on stbd side of clamp – the side facing away from the refraisal shroud, as shown in Figure 2 with the ducting removed.

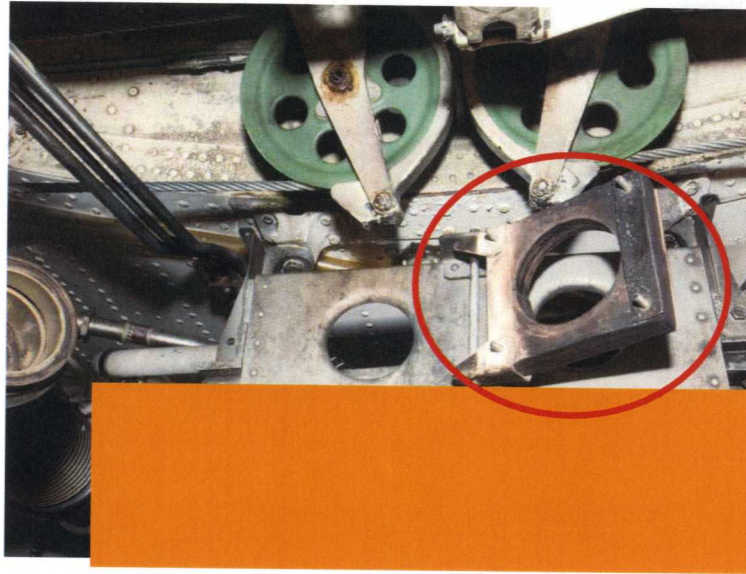
Figure 2 – Stbd Face of Ducting Clamp (note – surrounding area has had soot removed)

12. The evidence of heavy sooting in these locations, which were shielded from the refraisal shroud, implies that there could have been a fire in proximity to the clamp. The hypothesis is that a fuel-impregnated clamp, mounted against the ducting, could have ignited and created a small flame. This flame would have then, in turn, ignited the vapour of boiling OX87 held within the refraisal shroud (as previously hypothesised); this would have given the soot indications evident post-incident and described in previous reports.

13. The delamination of the clamp would have allowed a “wicking” effect, drawing fuel into it and the fire’s accelerant could be a combination of the AVTUR and the rubber bonding. The belief is that the rubber bonding may have changed composition after prolonged heat exposure from the ducting during normal usage, potentially changing its auto-ignition temperature.

14. BAES will analyse the ducting clamp to confirm that there is fire damage, rather than sooting.

15. BAES will investigate the auto-ignition temperature of the AVTUR / rubber bonding mix on a ducting clamp impregnated with AVTUR.
