Report of a Reconnaissance Visit
to Develop an
Enhanced Environmental Monitoring Programme
in the British-led Sector in Kosovo

Date Issued: June 2001

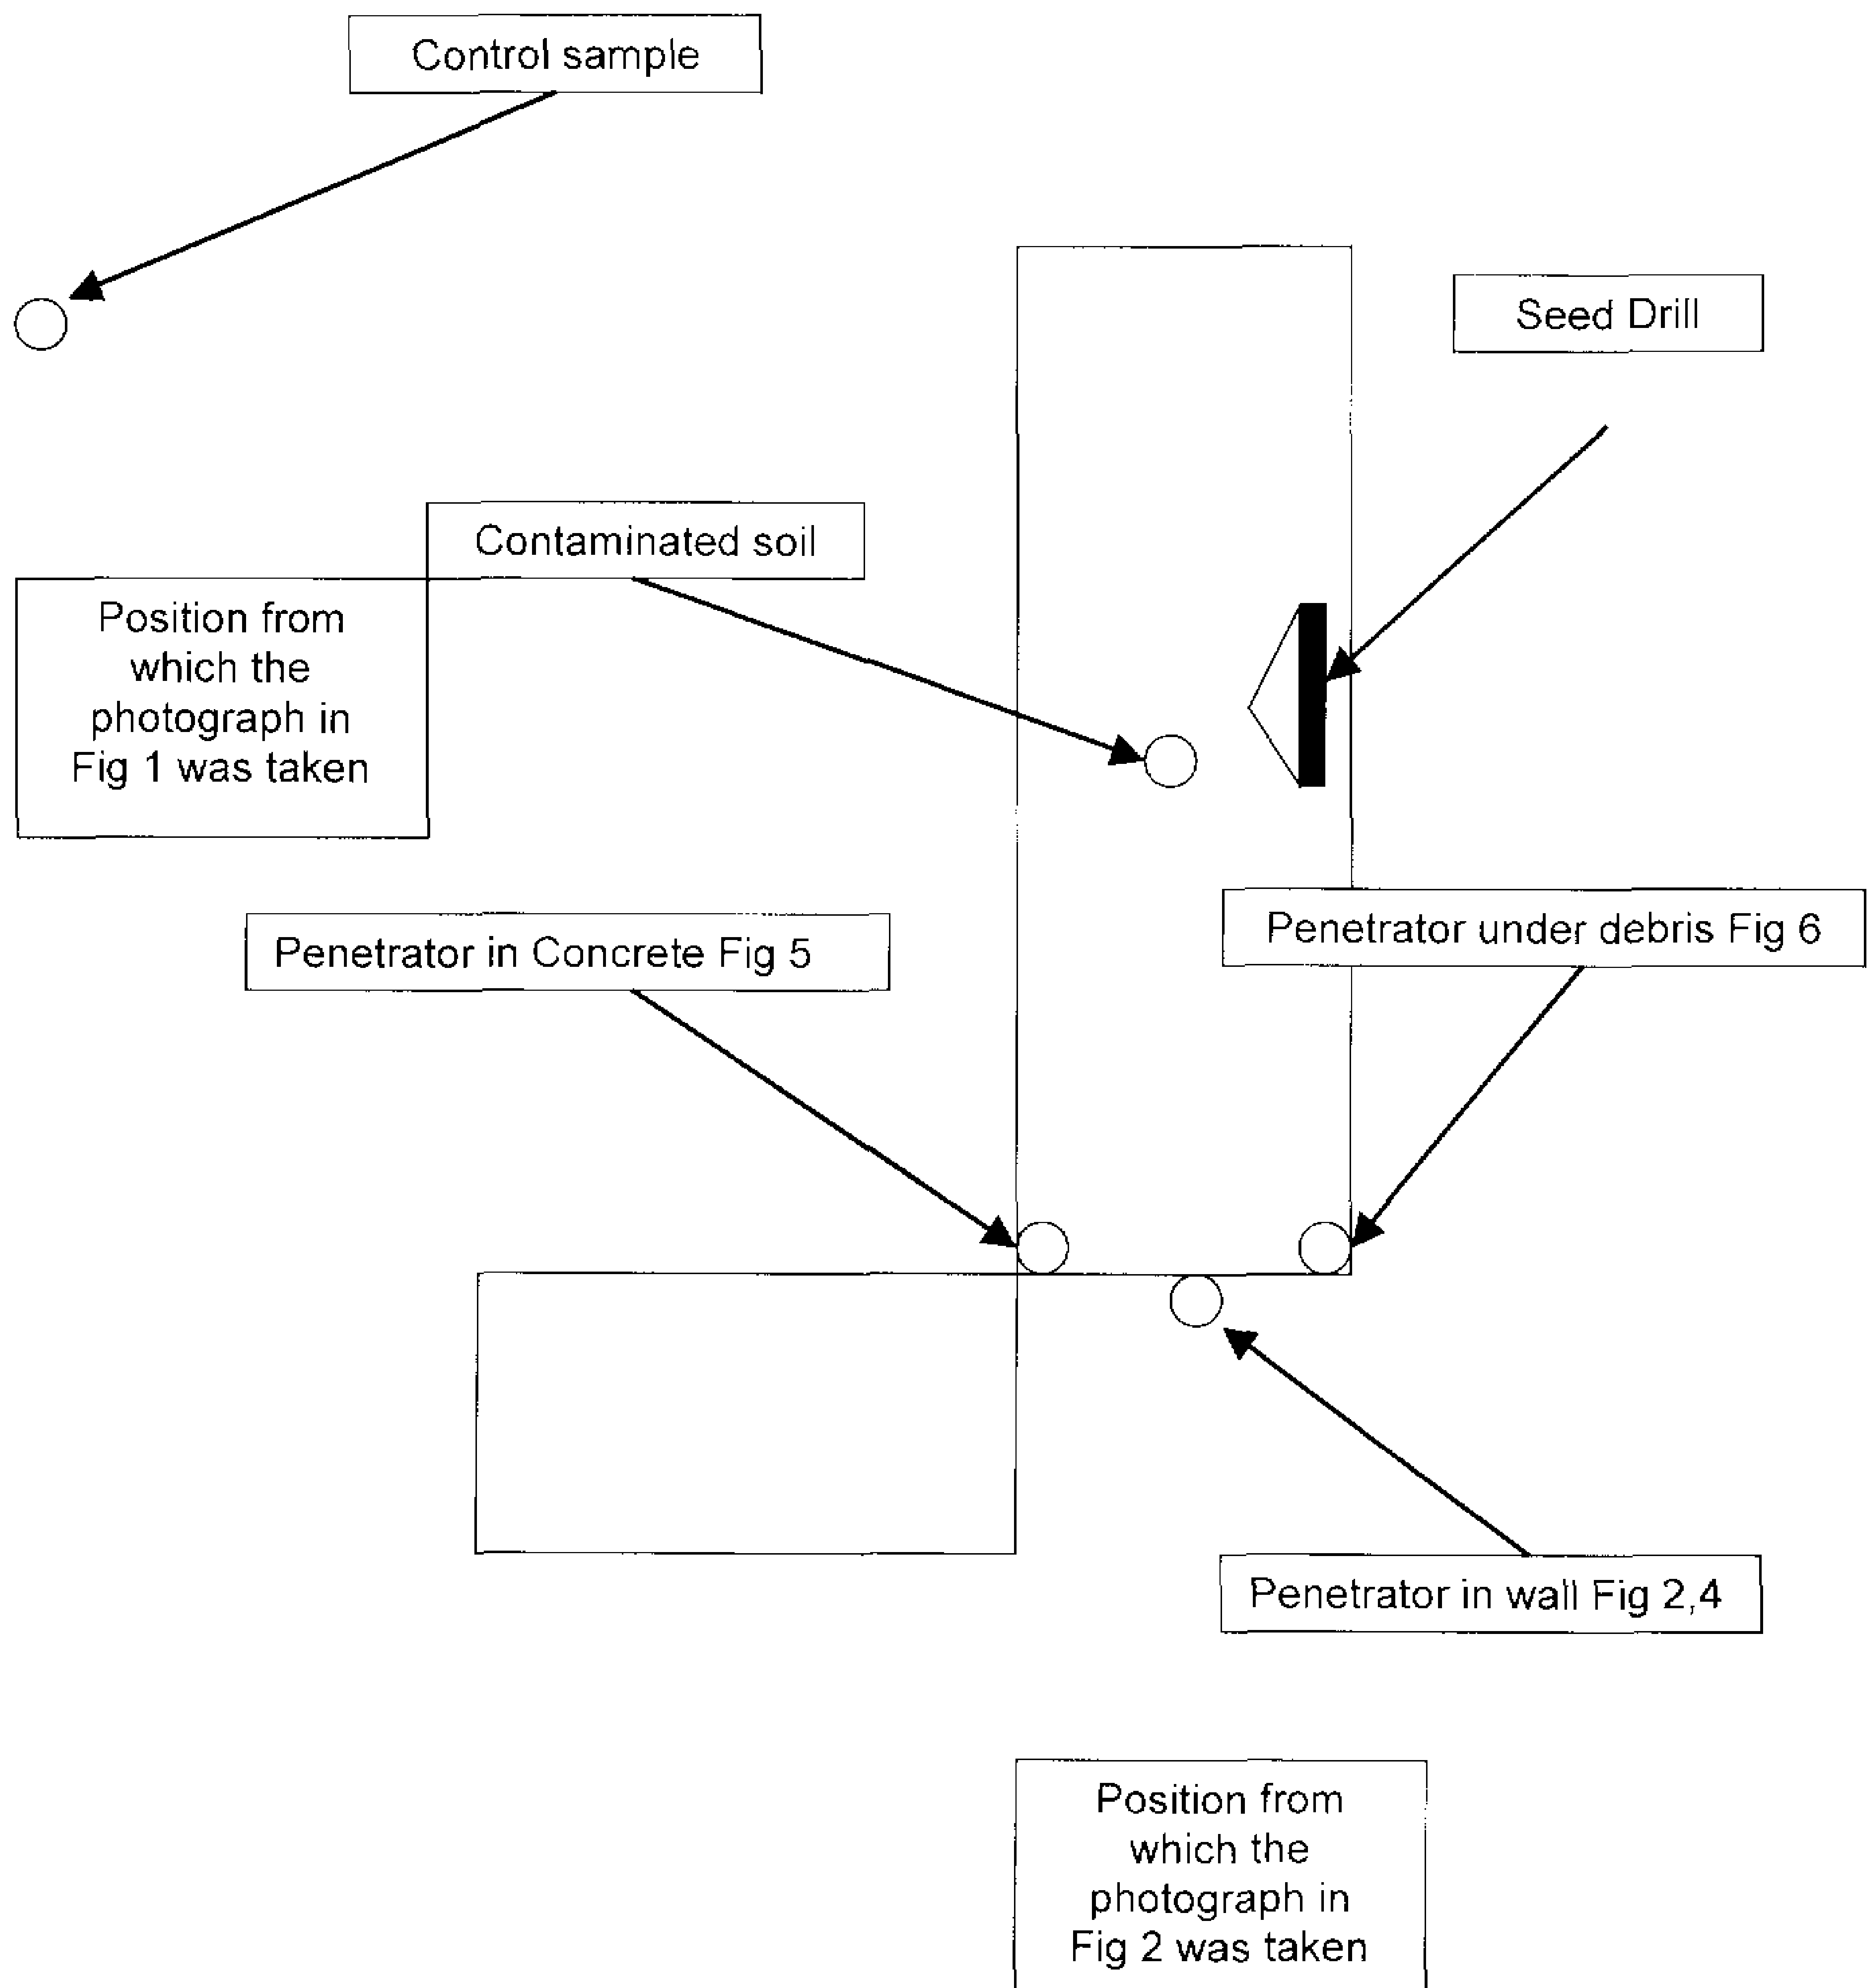
Sketch map showing the location of recovered rounds and sample locations

Assumed background on track 50 metres away from building: 80nSv/h
Inside damaged building: 120nSv/h
Close to bullet hole in seed drill: 80nSv/h

By damaged seed drill – diffuse source: 160 – 200nSv/h
Diffuse source – dose rate dependent on position

1B061001 – 1A Debris from brick wall
1B061002 – 1B Debris from brick wall
1B061003 – 2 Concrete beam
1B061004 – 3A Debris above corroded penetrator
1B061005 – 3B Soil around corroded penetrator
1B061006 – 4A Soil from area of elevated activity by seed drill – top 10cm
1B061007 – 4B Soil from area of elevated activity by seed drill – 10 to 20cm
1B061008 – 5A Assumed background – top 5cm
1B061009 – 5B Assumed background – 5 to 15cm
