**ROYAL AIR FORCE
PROCEEDINGS OF A BOARD OF INQUIRY
INTO AN AIRCRAFT ACCIDENT**

To inquire into an accident involving Tornado GR Mk4, ZA554 on 14 Nov 07 at
1510Z.

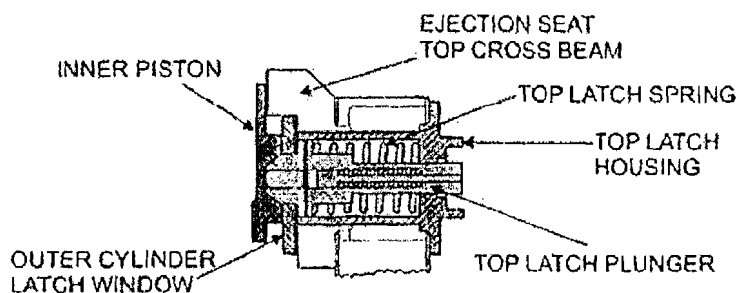
a. **Correct TLP Engagement.** Correct engagement of the flat section of the TLP with the flat surface of the top latch window on the ejection gun was essential to lock the seat to the aircraft. For the TLP to be correctly engaged 2 conditions had to be met. Firstly, the ejection seat had to be fully lowered down its guide rails with the ejection gun inner piston sufficiently retracted into the ejection gun such that the inner piston breech groove aligned with the top latch window on the outer cylinder of the ejection gun. Secondly, the TLP, under TLP spring pressure, had to pass through the top latch window on the ejection gun and locate in the breech groove on the inner piston. This would place the TLP in a position whereby the flat surface of the TLP was situated against the flat surface of the top latch window, thus locking the seat to the ejection gun. The TLP consisted of the plunger element, which was the body of the TLP, and a spring-loaded spigot, which ran through the centre of the plunger. Correct indication of a properly locked ejection seat was via a 2-part TLP check:

- (1) **Plunger Check.** The plunger was to be flush with or slightly below the top latch housing face on the seat.
- (2) **Spigot Check.** The spigot was to be flush with or slightly proud of the threaded end of the TLP body.

MBA Schematic of a correctly engaged TLP.
