TECHNICAL REPORT

Discipline or report series ^{#10} East Kilbride Technical Report	Document number ^{#12}	Report number ^{#52} DNS140121	Issue ^{#13} 1
Title ^{#15} ECU748 Performance Investigation			
Authors ^{#20} X X X	Telephone: X X X X	Date ^{#20} 15 th February 2008

This report details the investigation carried out on Spey Mk.251 engine serial number 748 at Rolls-Royce East Kilbride.

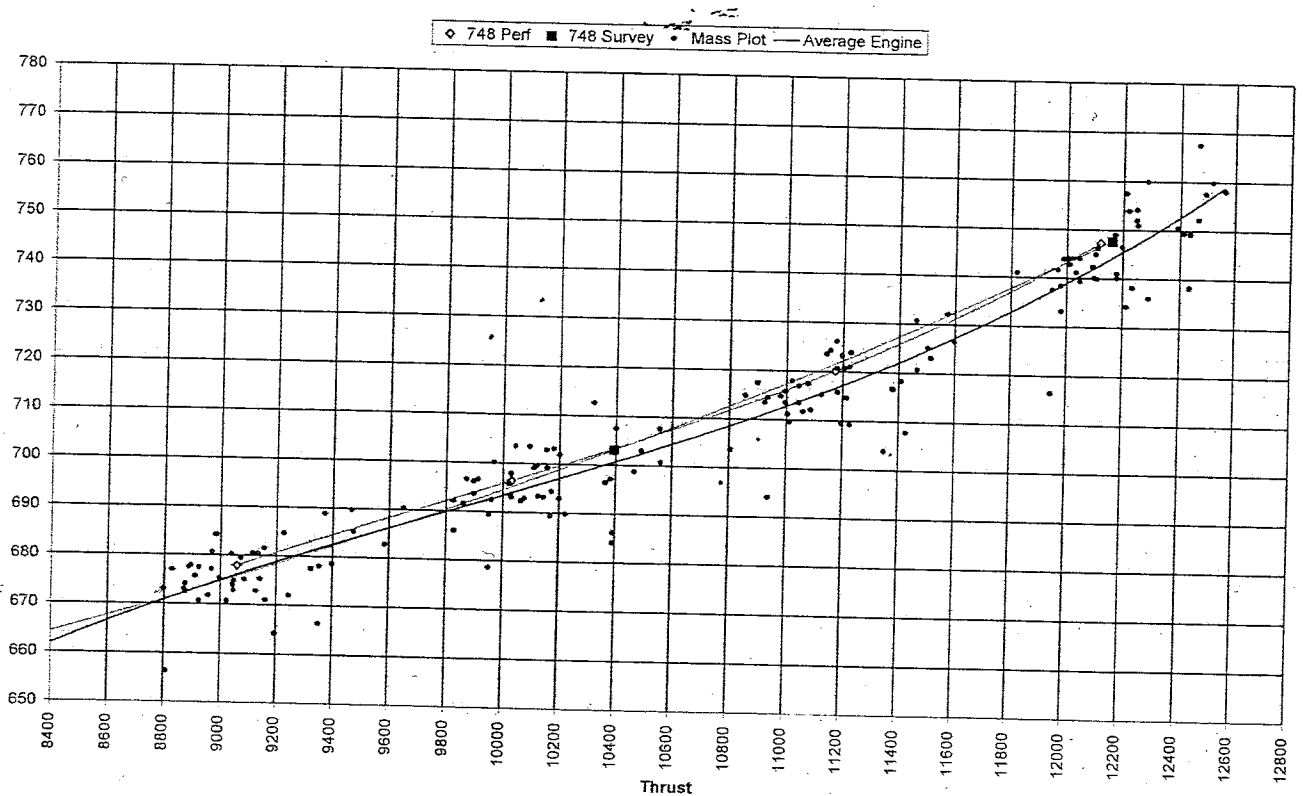
Figure 1: T3 Results

Across the standard range of performance curve running T3 was found to be within the test scatter of a standard pass off engine as shown below:

At the worst point the actual figures recorded for engine 748 were approximately 5°K above the average pass off engine but still within what would be considered to be normal test scatter.

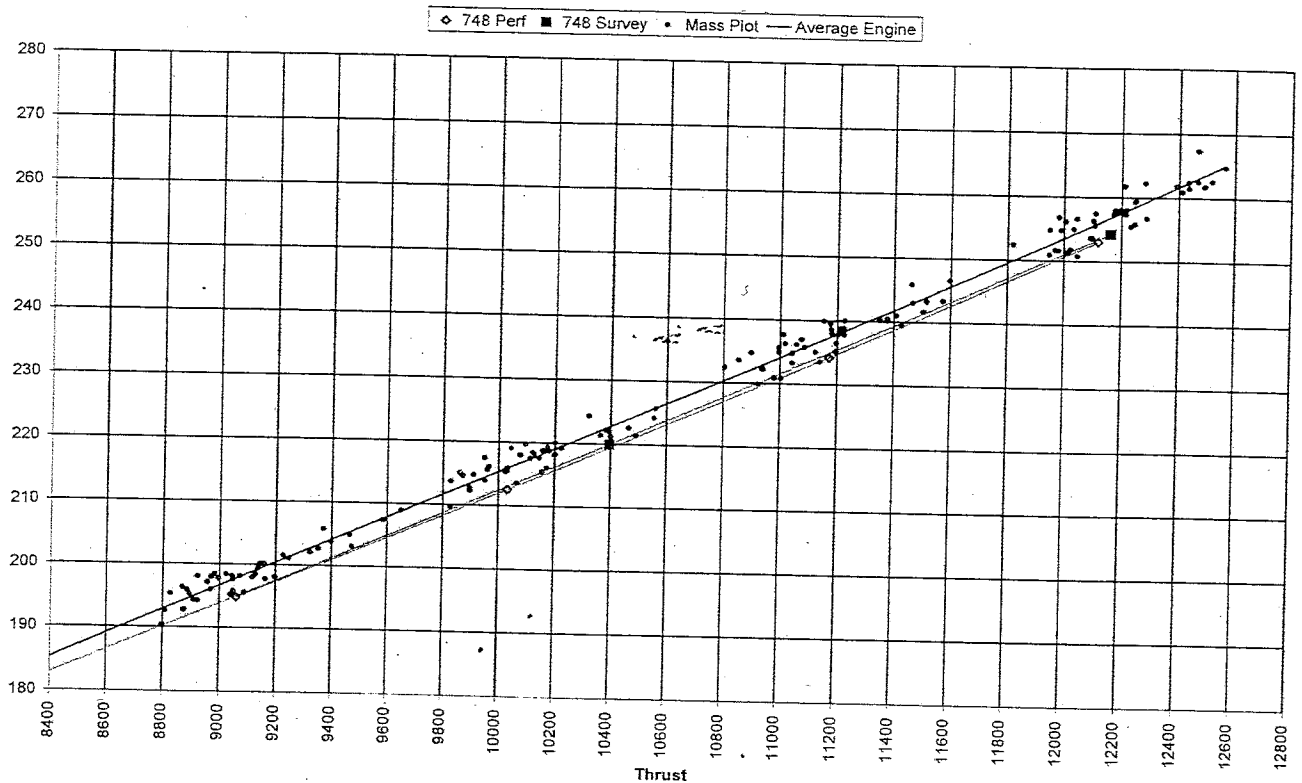
Figure 2: P3 Results

Across the standard range of performance curve running P3 was found to be within the test scatter of a standard pass off engine as shown below:

At the worst point, the recorded P3 is approximately 4psi lower than the average pass off engine. Again though this is still considered to be in the normal test scatter although at the lower end.

Any deviation in engine performance from the average can be explained by engine deterioration over the engines 10 year operational life since installation coupled with normal engine test scatter.
