DATE	8 AUG 2007		LOCATION AND GRID REFERENCE	HUDSWELL GRANGE CATTERICK TRAINING AREA SE. 139 987		
AIRCRAFT TYPE(S)	MARK(S)		SERIAL NUMBER(S)	PARENT UNIT(S)		
PUMA	HCI		ZA 934	RAF BENSON		
NAME(S) OF PILOT(S)	Flt Lt SALE (Capt)		PARENT UNIT(S)	33 SQN RAF BENSON		
	Flt Lt HAMILTON (Co)					
NUMBER OF CASUALTIES						
KILLED			INJURED			
CREW	PASSENGERS	OTHERS	CREW	PASSENGERS	OTHERS	
2	1	-	1	8	-

SERVICE INQUIRY INTO THE ACCIDENT INVOLVING PUMA MK1 ZA934 ON 08 AUG 07

**SERVICE INQUIRY REPORT INTO THE
RAF PUMA HELICOPTER ZA934 ACCIDENT
AT HUDSWELL GRANGE, CATTERICK TRAINING AREA
ON THE 8 AUGUST 2007**

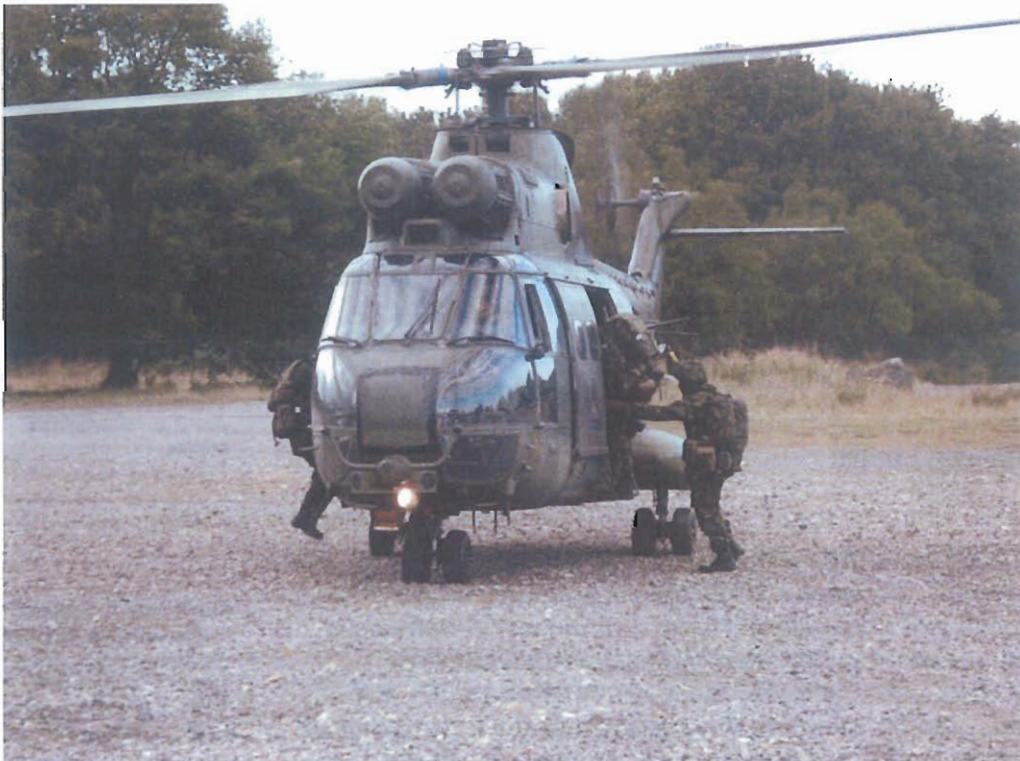
(Fig 2. Puma ZA934)

3. **Aircraft Background.** ZA934 (Fig 2) Entered RAF service on the 28 May 1980. It had no history of significant incidents or accidents prior to 8 August 2007. The airframe had deployed to Iraq in June 2006 and May 2007. It had 'Desert Recovery' and 'Primary Star' engineering servicing work conducted after both Iraq Detachments. It went into AgustaWestland Helicopters (Yeovil) for Self Defence System (SDS) modifications and upgrades between October and November 2006 and then had a 'Penalty Primary Star' servicing in June 2007 due to airframe life and servicing extensions put in place because of Operational demands.

[Fig 2] Puma HC1 ZA934 pictured at Shaiba Landing Site, CTA pictured at 19:50.34L, 8 August 07, approx one hour prior to the accident. Picture: ITC Trp Cdr.

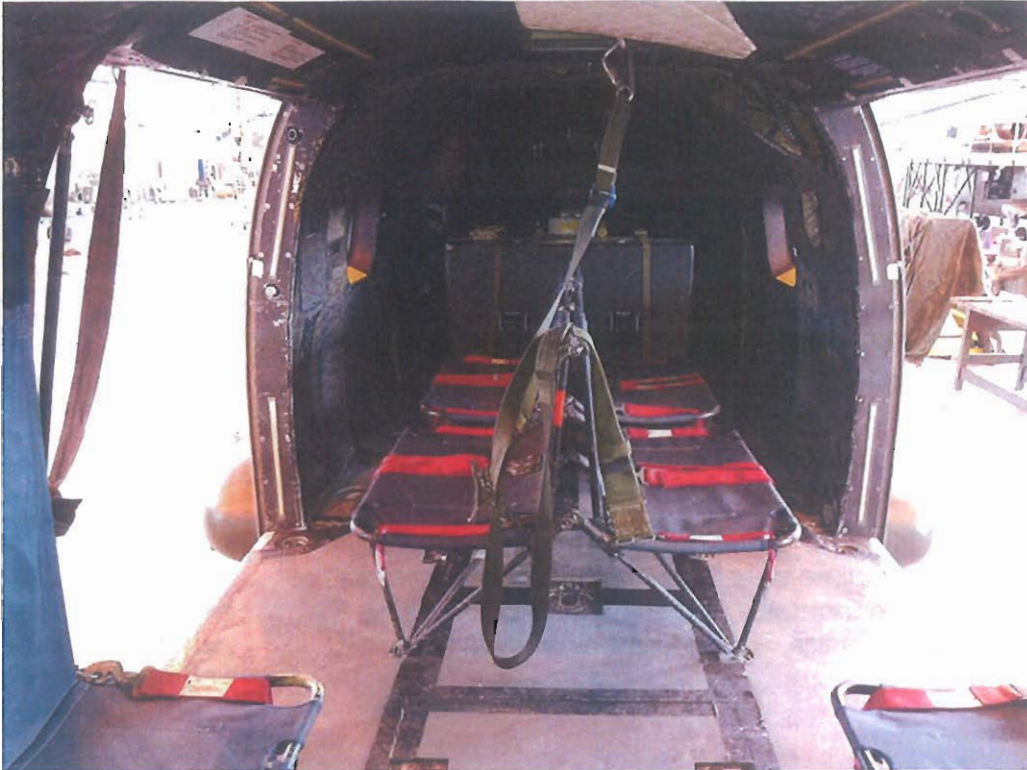
(Fig 3. Puma Cabin in representative Role Fit)

4. For its task at Catterick, ZA934's role fit was 12 seats fitted in the cabin with a Crashworthy Auxiliary Fuel Tank (CAFT) also fitted at the rear of the cabin. If required this would extend the aircraft's working endurance from 1hour 45min to 2hour 15min (see Fig 3).

[Fig 3] Puma HC1 Cabin viewed from the Crewmans centre seat looking aft. The CAFT (which holds 310kg of fuel) is seen at the very back of the cabin area.

The Crewman's Harness is secured to the bottom of the Main Rotor Gearbox (top centre of Fig 3).

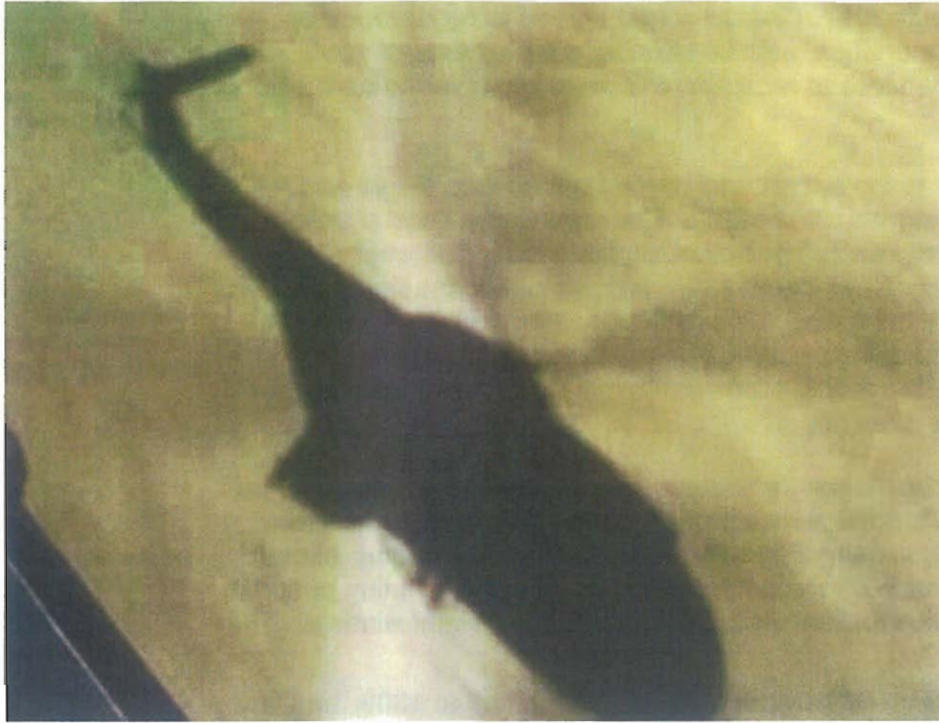
(Fig 7 – ZA934 Shadow at Low-level Flight)

21. **Afternoon Tasking – 8 August 2007.** ZA934 Lifted at 1309L and flew to Hudswell Grange Farm to carry out troop briefings and familiarisation flights for the Officer Commanding (OC) the ITC Parachute Regiment Troops. During this tasking period ZA934 was routinely flown down to 50' agl both on and off the range area. The crew also flew ZA934 to West Grange Farm, approximately 6 miles NW of CTA, at the request of OC ITC Paratroops Company to view a friend's property from the air. Camera clips recorded onboard ZA934 during this period indicate troops incorrectly briefed and seated for familiarisation flights [30], and inappropriate low-level flight conducted over populated areas (The Swaledale Caravan Park [31]) for which a sequence of anxious and concerned flying complaints was later logged with the Civil Aviation Authority, Civilian Police and RAF Leeming [32] (See also Fig 6 & 7).

[Fig 7] Image taken by troops onboard ZA934 during tasking on 8 August 07.
