TECHNICAL REPORT

Discipline or report series ^{#10} East Kilbride Technical Report	Document number ^{#12}	Report number ^{#52} DNS140121	Issue ^{#13} 1
Title ^{#15} ECU748 Performance Investigation			
Authors ^{#20} X X X	Telephone: X X X X	Date ^{#20} 15 th February 2008

This report details the investigation carried out on Spey Mk.251 engine serial number 748 at Rolls-Royce East Kilbride.

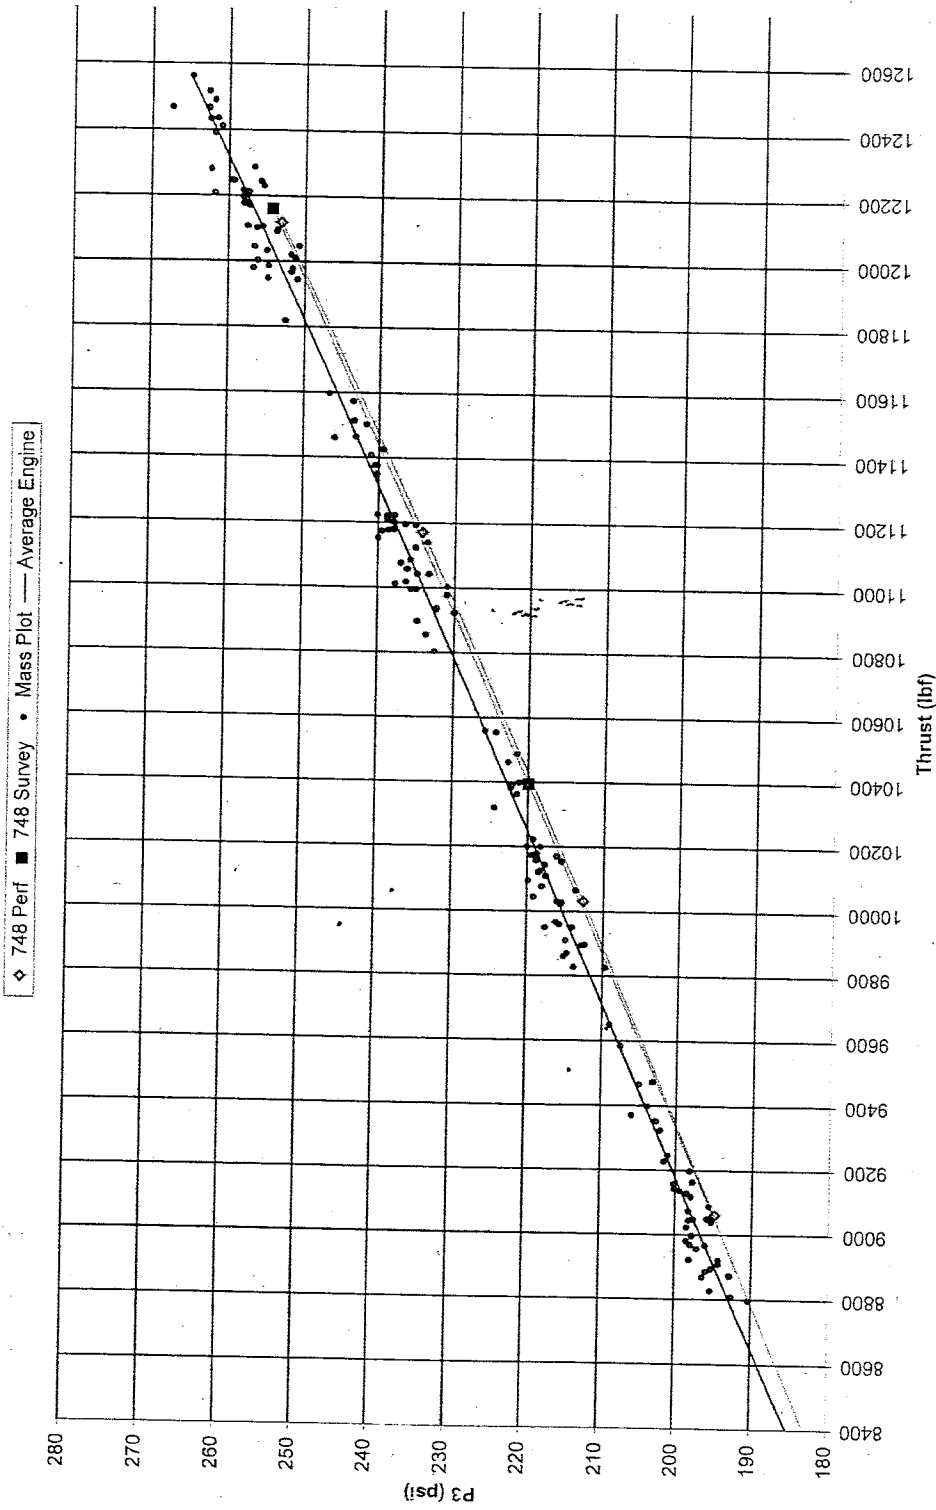
Appendix 1: Corrected Performance Data – P3 v Thrust

Across the standard range of performance curve running P3 was found to be within the test scatter of a standard pass off engine as shown below:

Any deviation in engine performance from the average can be explained by engine deterioration over the engines 10 year operational life since installation coupled with normal engine test scatter.

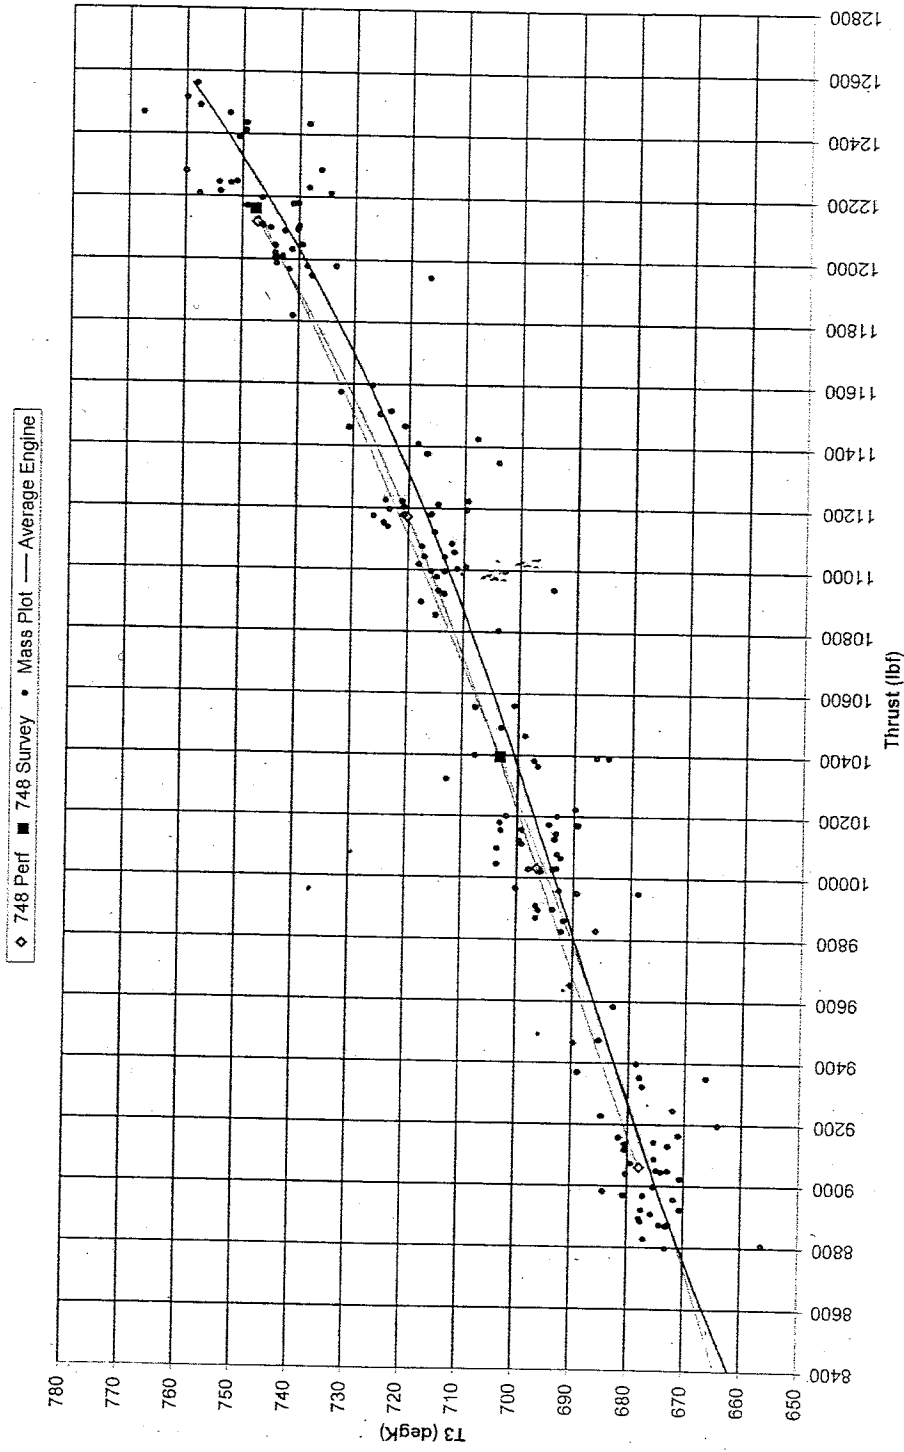
Appendix 1: Corrected Performance Data – T3 v Thrust

Across the standard range of performance curve running T3 was found to be within the test scatter of a standard pass off engine as shown below:
